STATE OF NEW HAMPSHIRE

Impairments Added to Categories 4A, 4B, or 4C of the 2016 305(b) Report

May 8, 2017

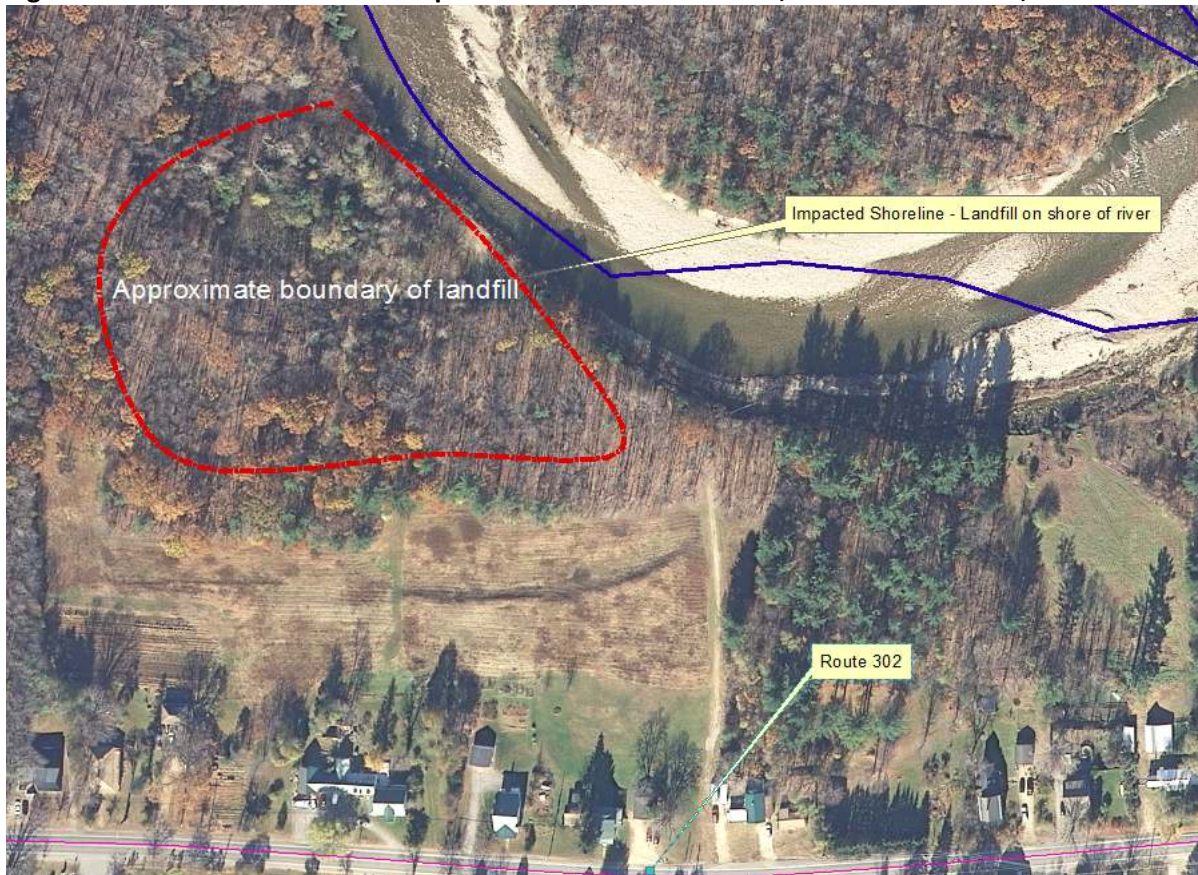
Figure 1. Location of landfill and impacted shoreline -71.278191, 44.080262 Bartlett, NH.

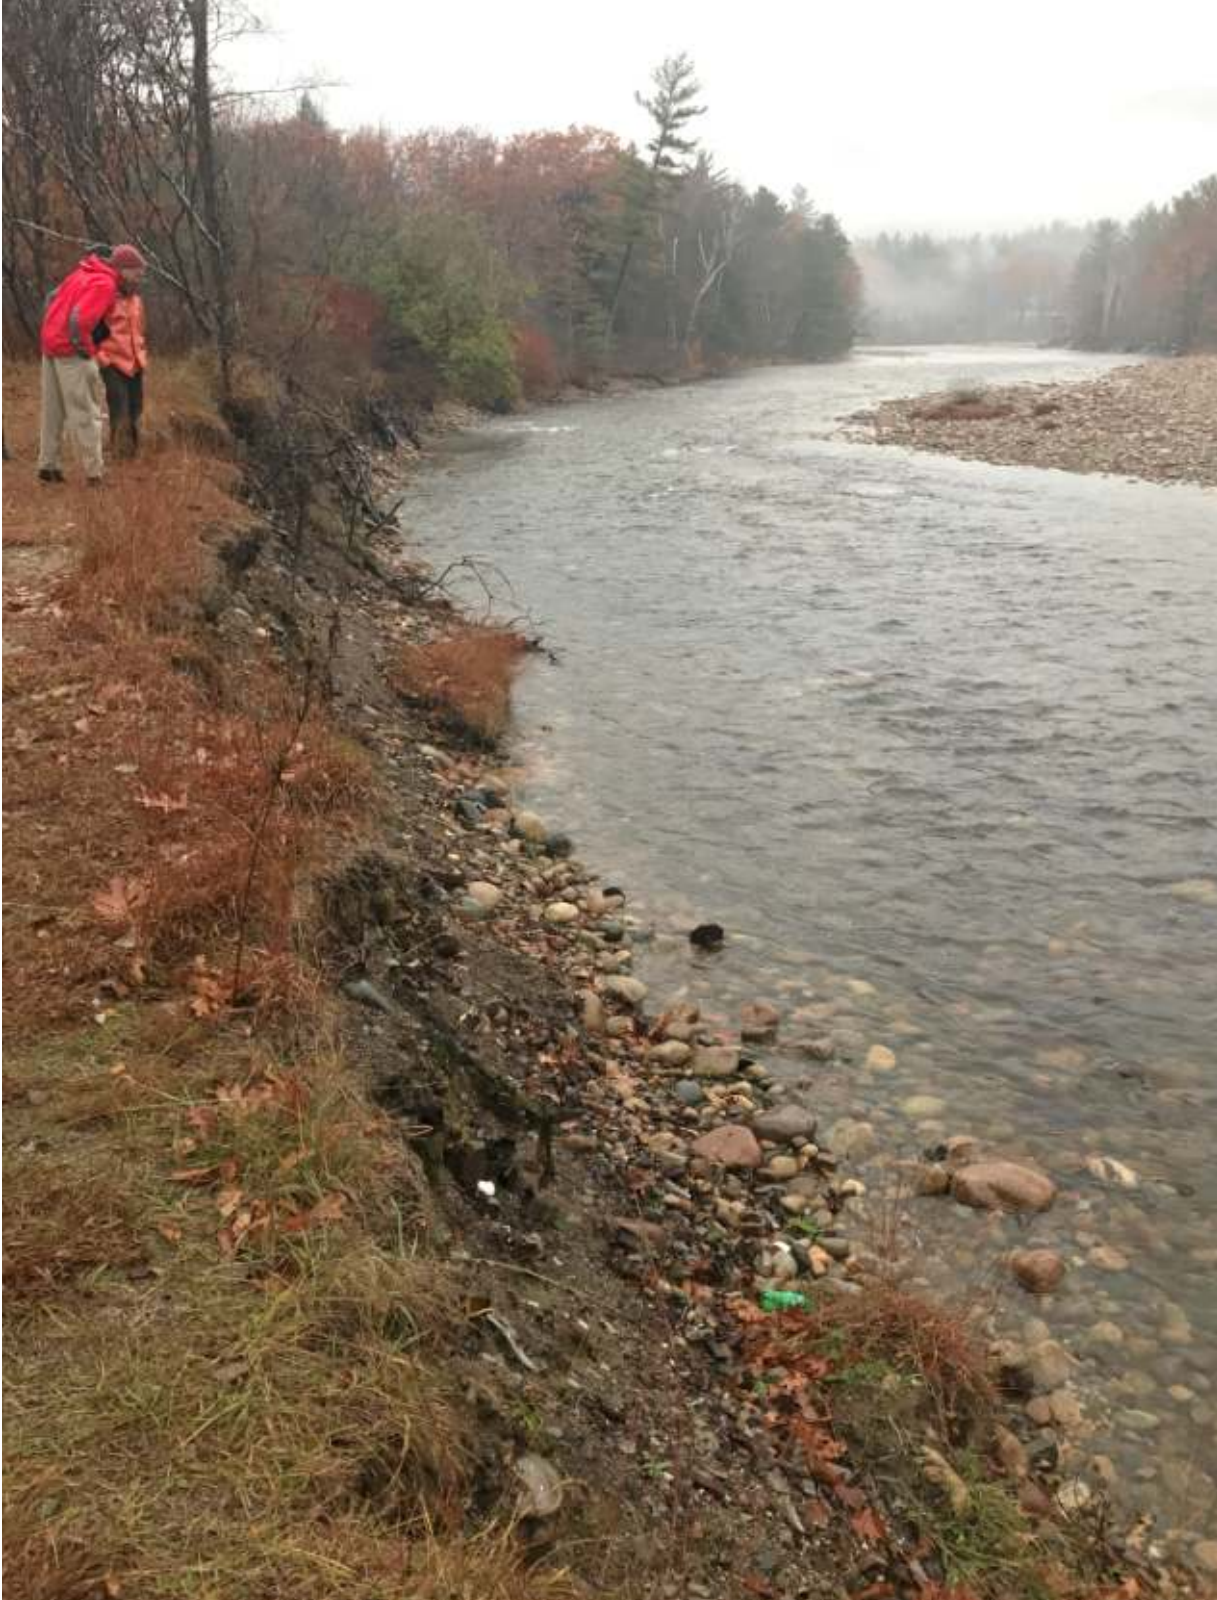
Figure 2. Southern shore of the Saco River. This is the section of the river where the bank is eroding and material from the landfill is eroding into the river. The landfill comprises approximately 300 feet of the shoreline.

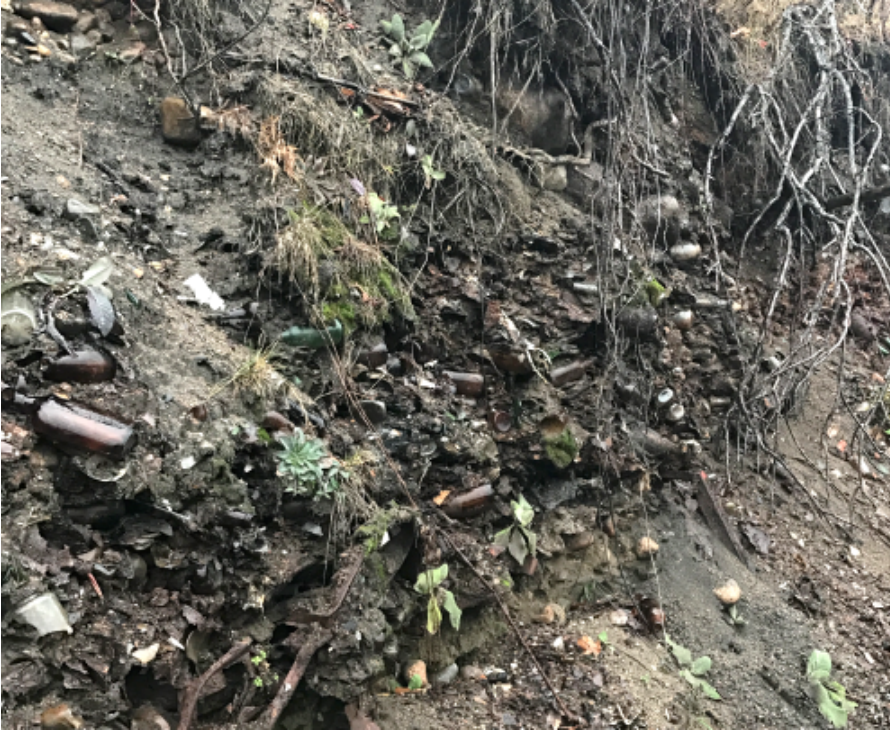
Figure 3. The eroding bank of the river showing materials from the landfill. The bank is very unstable – and

undercut.

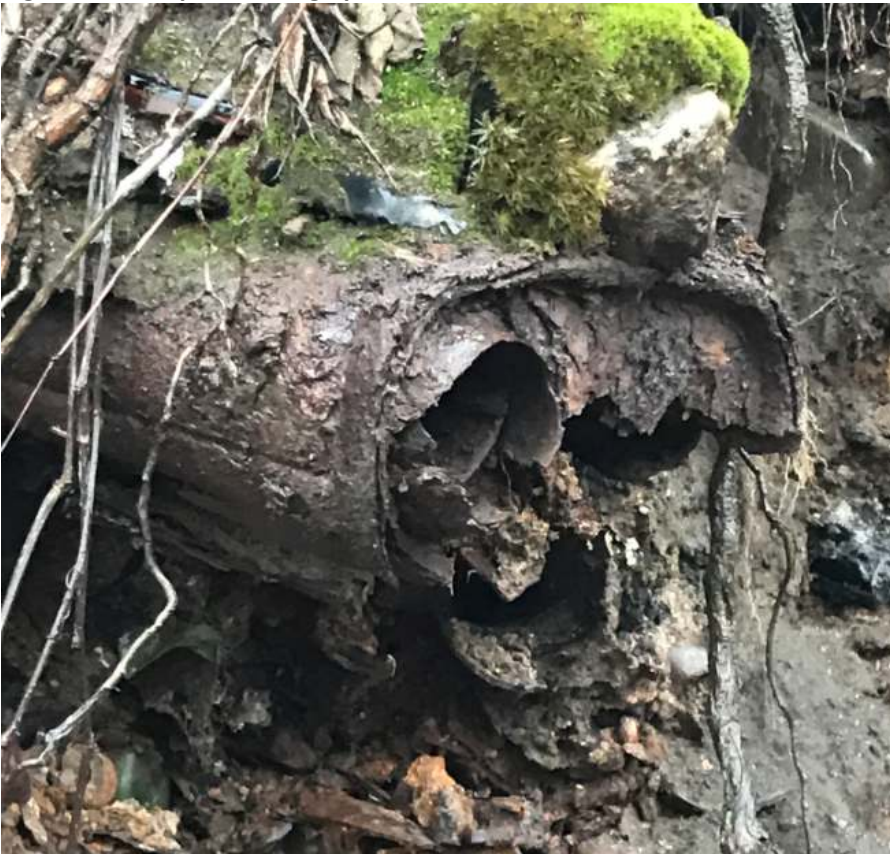
Figure 4. Example of a large piece of metal debris within the bank.

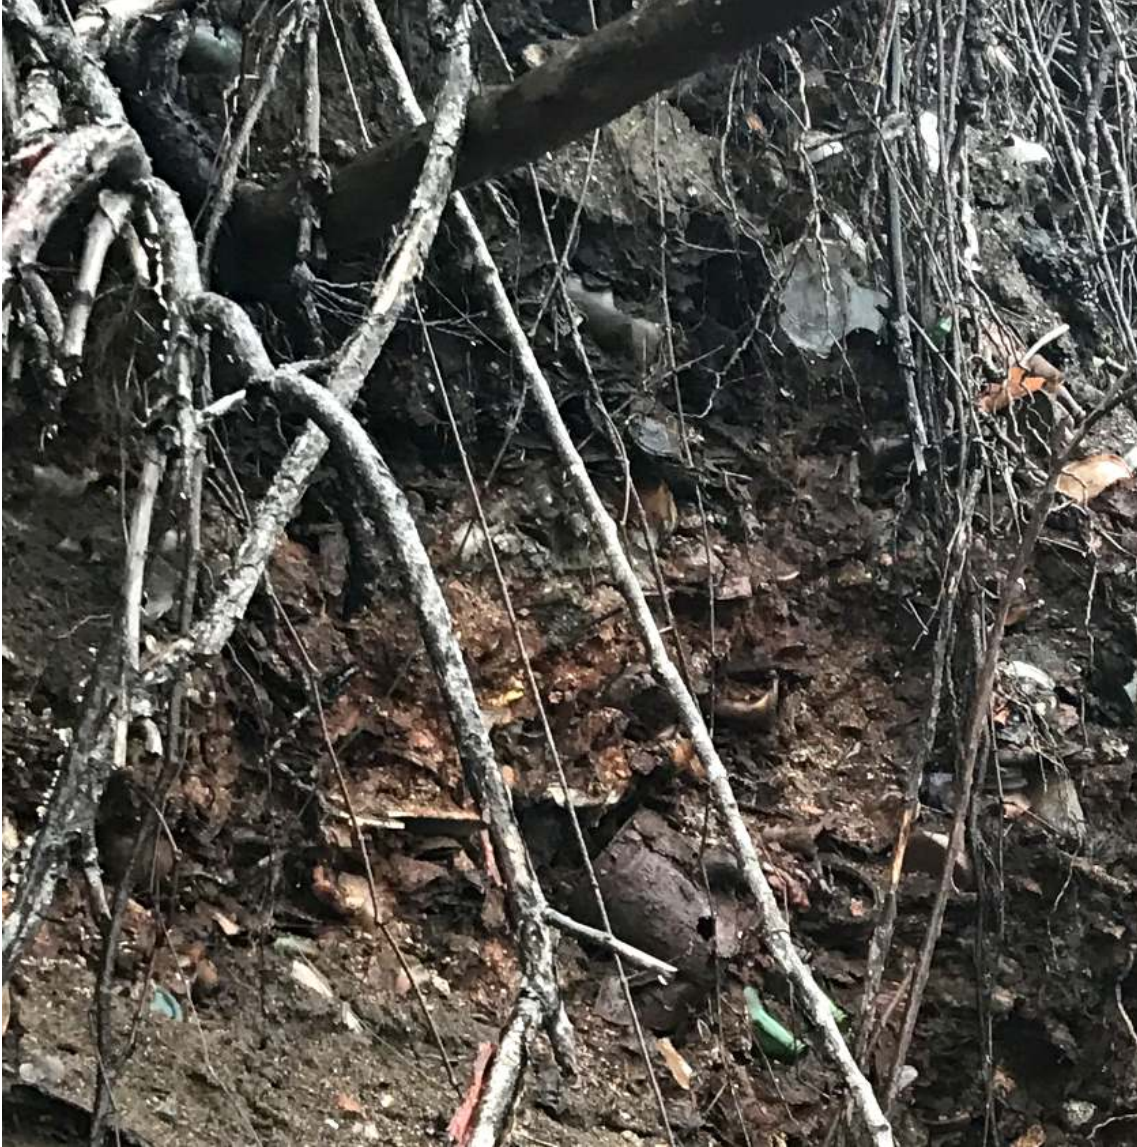
Figure 5. Metal and glass debris embedded in the eroding shoreline. The tree roots depict how undercut and unstable the bank has become.
